## Slope Failure Investigation in Weathered Granitic Rock Mass Using Electrical Resistivity Imaging: Case Study in Kg Bukit Selar, Jeli, Kelantan, Malaysia

To cite this article: Nur Azra Zainol Abidin *et al* 2020 *IOP Conf. Ser.: Earth Environ. Sci.* **596** 012056

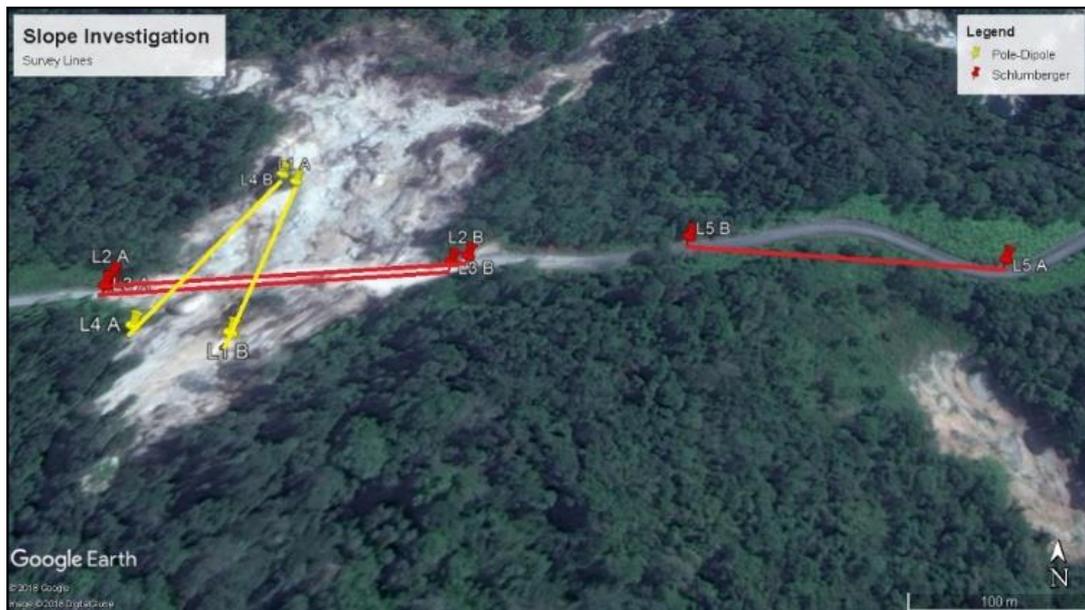
**Figure 2.** Location of resistivity survey lines conducted in the study area. The scar of a slope failure can be seen in the image

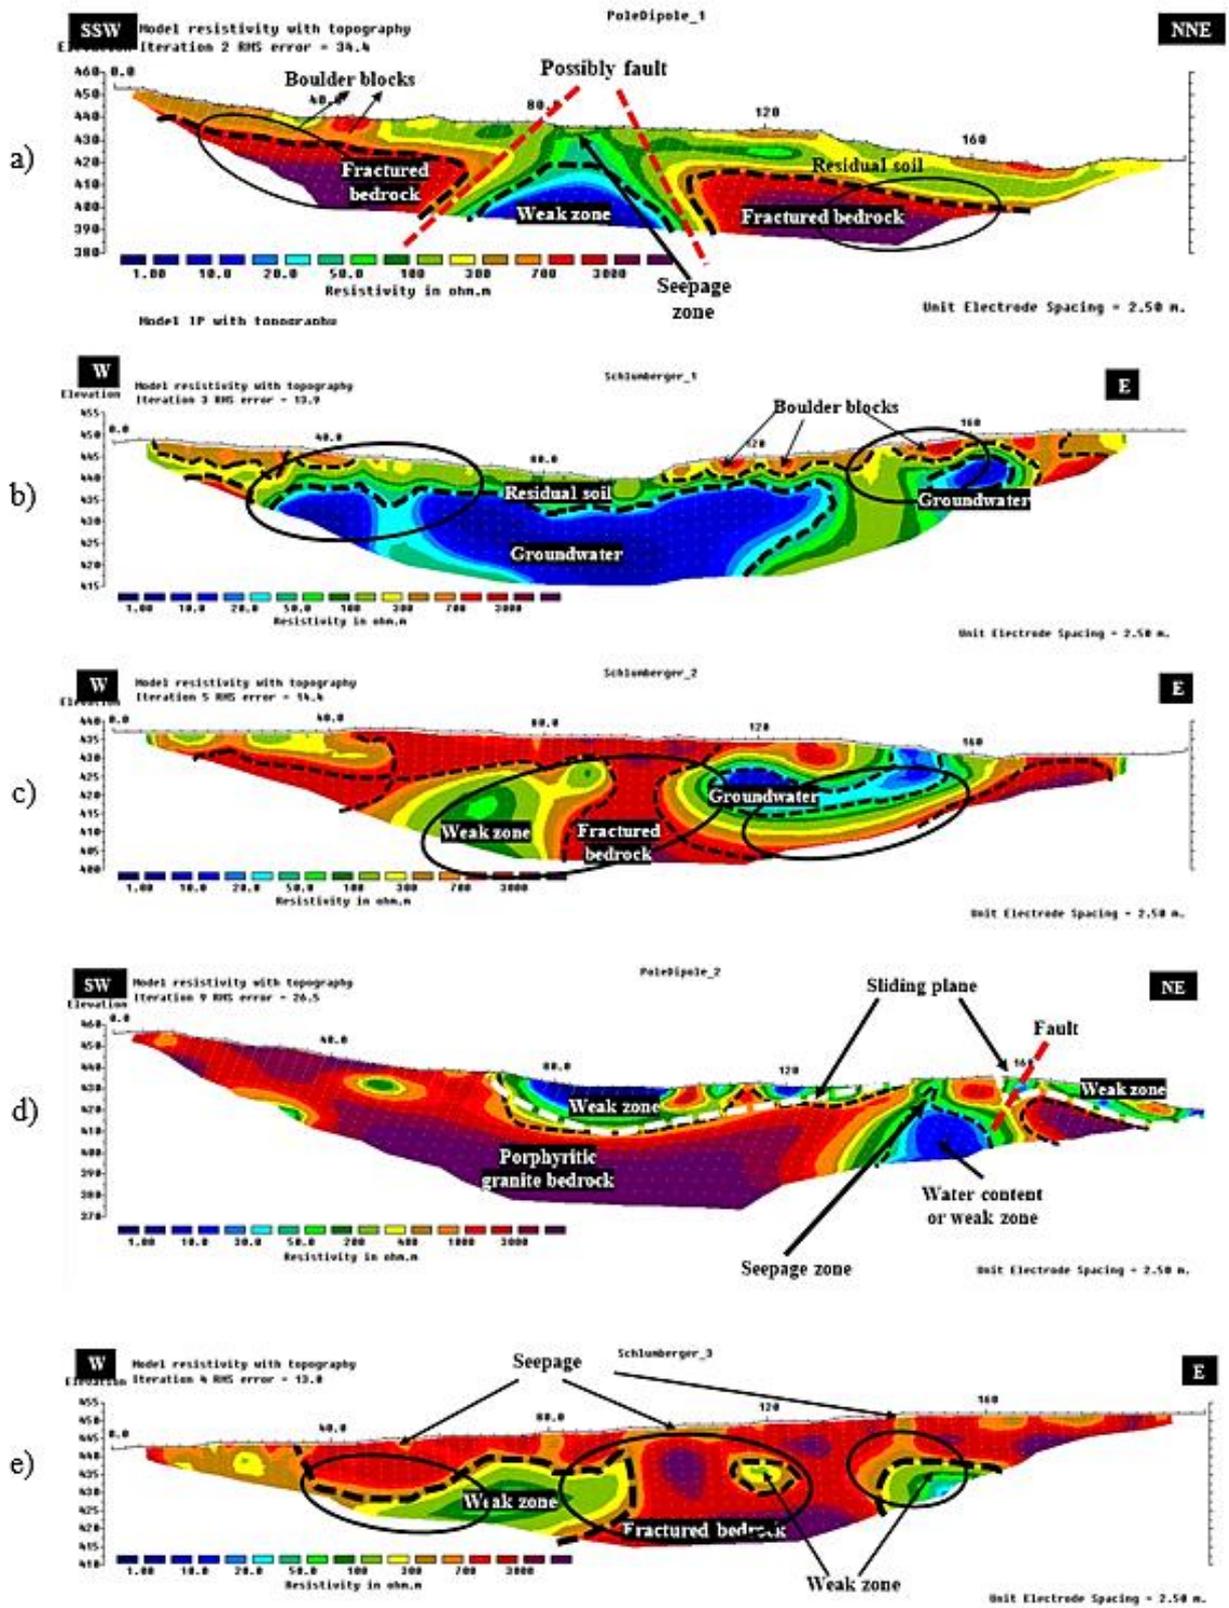
Survey Line 1 is 200 m in length in the vertical direction on the slope surface. Pole-dipole protocol is used for this line with 5 m electrode spacing. The survey line is directed from SSW to NNE. From Figure 3, the highest resistivity values zone is at 700  $\Omega\text{m}$  until more than 3000  $\Omega\text{m}$  in the bottom part, which interpreted as the fractured granite bedrock region. This zone is located at spread 0 m to 62.5 m and 120 m to 155 m. It is interpreted as a fractured rock due to the lower chargeability value (1 msec to 2 msec) in which shows the presence of water content in the zones. By comparing the resistivity method and IP method, the existence of water can be predicted existing in dense rock.

There is a seepage zone that can be seen clearly at approximately 87.5 m spread on Survey Line 1. There is a low resistivity zone at the bottom part of the pseudo section, which shows the source of seepage flow from the dense subsurface rock according to IP values ranging from 10 msec to 20 msec. Several rotated blocks, cracks, and head scarps can be seen at the upper part of the pseudo section. The zone is approximately 10 m deep from the ground surface. Vertical electrical contrast in the thin layer of the top part of the slope shows the sliding plane of the slope failure. There is a fault that can be seen due to the discontinuity of rock at spread 70 m and 97 m.

Survey line 2 is 200 m in length which the direction is parallel to the slope surface. Schlumberger protocol is used for this line with 5 m electrode spacing. The lowest resistivity values area around 1  $\Omega\text{m}$  to 20  $\Omega\text{m}$  in the bottom part in which resides most of the pseudo section, can be interpreted as the water content region. This zone located at an elevation between 415 m to 440 m. Low IP values which ranging from 2 msec to 3 msec is indicated water content (black circle). By comparing resistivity value and IP value, the existence of water can be detected existing in the fractured zone. Meanwhile, the top part of the pseudo section, which has high resistivity values start from 300  $\Omega\text{m}$  to more than 700  $\Omega\text{m}$ , is interpreted as the boulder blocks of porphyritic granite rock.

Survey Line 3 is 200 m, and its directed parallel with slope face. Schlumberger protocol is used for this line with 5 m electrode spacing. The ERI survey spread Line 3 is in the W-E direction. The highest resistivity values area at 700  $\Omega\text{m}$  to more than 3000  $\Omega\text{m}$  in the bottom part, which can be interpreted as the granite bedrock region. This zone is located at an elevation between 400 m to 410 m.

The lowest resistivity zone in this pseudo section has resistivity values ranges from 10  $\Omega\text{m}$  to more than 20  $\Omega\text{m}$ . The colour of the region is blue to light blue at elevation 435 m to 475 m. Low resistivity values zone indicates the presence of water content or highly conductive materials. IP values ranging from 2 msec to 3 msec shows water content, which shown the existence of a weak zone for this slope. There is an overflow seepage zone can be seen clearly at approximately 10 m spread on survey Line 3

The length of the survey line 4 is 200. Pole-dipole protocol used for this line with 5 m electrode spacing. The total electrodes used are 41 electrodes which the first electrode start at the coordinate of N05°29'13.1", E101°50'41.8" and last electrodes at coordinate N05°29'17.7", E101°50'43.2". The orientation of the survey spread line 4 is in the SW–NE direction. The highest resistivity values zone is at 1000  $\Omega\text{m}$  until more than 3000  $\Omega\text{m}$  in the bottom part, which interpreted as the granite bedrock region. This zone is located at an elevation between 370 m to 420 m.

Low resistivity values show the existence of water content for this slope at almost 10 m deep from the ground surface. The line 4 pseudo section shown the presence of the seepage zone, which seen at the end of survey line 4. There is a low resistivity zone in the pseudo section, which shows the source of seepage flow from the subsurface. The uppermost zone shows the thin layer of loose to dense residual soil with moist to dry condition at spread 70 m to 200 m from the first electrode point. Several rotated

blocks, cracks, and head scarps can be seen at the upper part of the pseudo section. Vertical electrical contrast in the thin layer of the top part of the slope shows the sliding plane (white lines) of the slope failure.

Figure 3. Pseudo section of resistivity survey from the study area; a) line 1, b) line 2, c) line 3, d) line 4, e) line 5

The Schlumberger protocol was used for a survey line 5 with 5 m electrode spacing. The total length for the survey spread was 200 m, with the survey orientation is in the E-W direction. Figure 3 shows the resistivity values for line 5, which is ranging from 700  $\Omega\text{m}$  to more than 3000  $\Omega\text{m}$ . This resistivity value was interpreted as the fractured granite. The IP values are 1 msec to 2 msec, which indicates the potential presence of groundwater. By comparing resistivity value and IP value, the existence of water can be detected existing in the fractured zone. The highest resistivity value (more than 3000  $\Omega\text{m}$ ) covered at the bottom part of the profile at elevation 410 m to 420 m, and some are at elevation 430 m to 440 m. The low resistivity values zone indicates the existence of a weak zone for this horizontal spread line between Slope 1 and Slope 2. There are several seepages formed on the rock body.

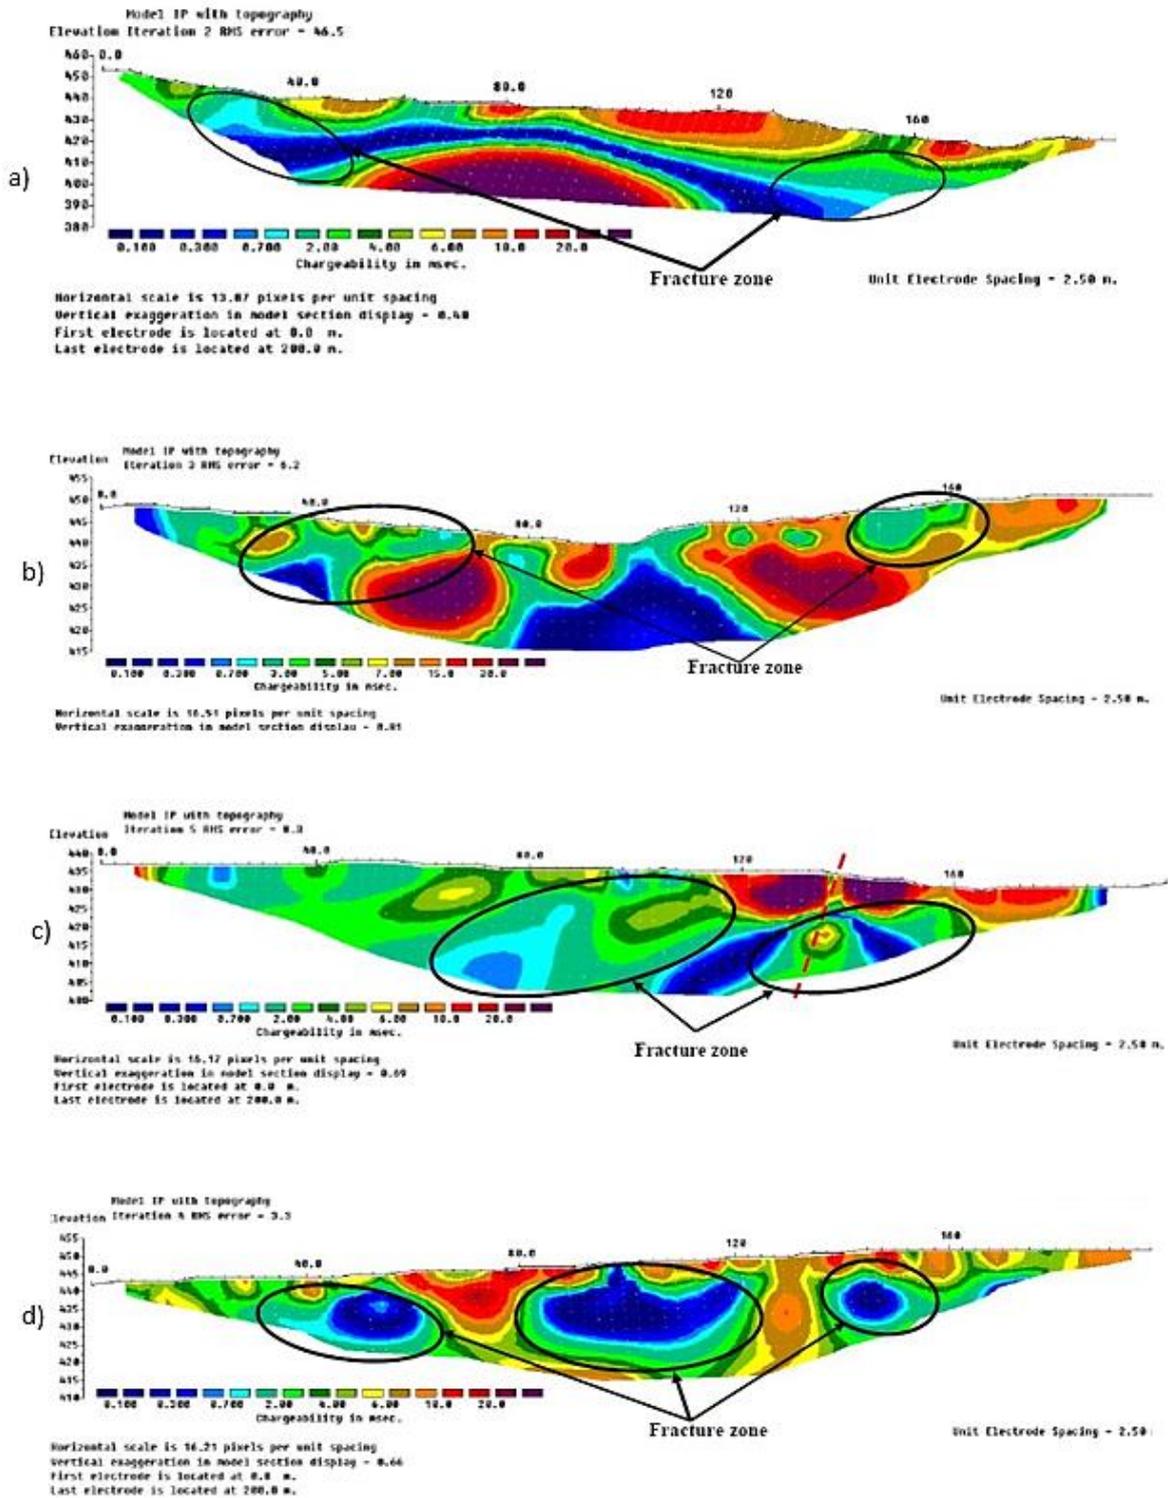
For slope investigation, both resistivity and induced polarization parameters are utilizing to study the subsurface model for factors of slope failures interpretation. Results for the ERI surveys are presented in pseudo-section models in Figure 3 and Figure 4. In resistivity measurement, the lowest resistivity value ranging from 10 to 100 Ohm.m indicates saturated soil or water content zone. High resistivity value ranging from 700 Ohm.m to 3000 Ohm.m indicates a hard rock zone. For loose soil zone, the resistivity value is low, which ranging from 300 Ohm.m to 700 Ohm.m. Loose soil zone represents the slope failure area that occurred at the study area. Meanwhile, for model induced polarization (IP) measurement, the chargeability of water is 0 msec. Thus, by comparing the resistivity method and IP method, the existence of water can be predicted and detected either the water is existing in dense rock or fractured rock.

Figure 4. Result of IP pseudo section with the topography; a) line 1, b) line 2, c) line 3, d) line 5
