INTERNATIONAL HERITAGE AND CULTURAL CONSERVATION CONFERENCE

INHERIT 2023

Types of Damage to Heritage Buildings in Malaysia Caused by Plants: A Comprehensive Investigation

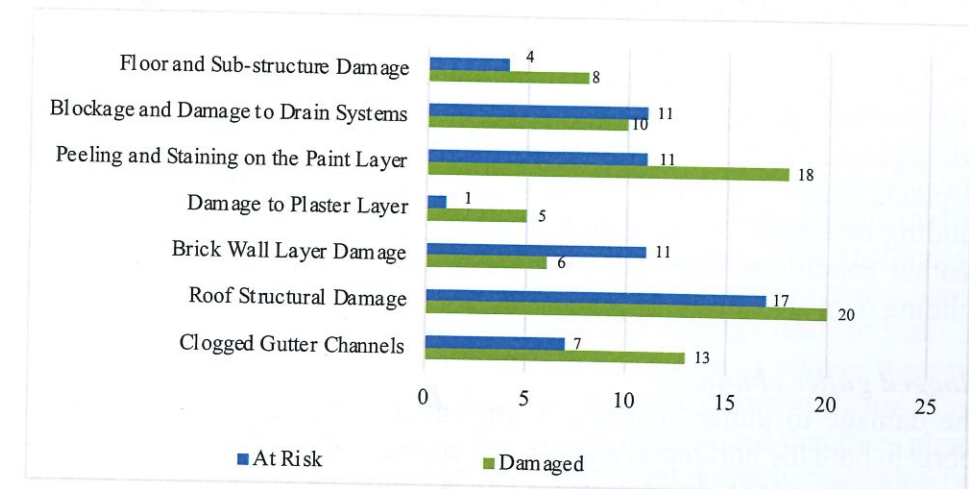
Figure 1: The number of heritage buildings in Malaysia at risk of plant damage

The observations showed that roof structural damage is the most encountered, followed by peeling and staining on the painted wall, blockage and damage to drain systems, clogged gutter channels, brick wall layer damage, floor and sub-structure damage and damage to plaster layer (Figure 1). The interview sessions revealed that the most common forms of damage encountered during conservation work are clogged gutter channels, floor and sub-structure damage and peeling and staining on the painted wall followed by roof structural damage, brick wall layer damage, damage to plaster layer and blockage and damage to drain system (Table 1). Each type of damage caused by plants varies depending on the situation such as the building's location, building materials, building design, plant types, environmental factors, and weather conditions. The following are details regarding the seven types of building damage caused by plants:
