Analysis of the Causes of Destruction of Two British Pillboxes in Bachok, Kelantan

To cite this article: Nur Athmar Hashim *et al* 2020 *IOP Conf. Ser.: Earth Environ. Sci.* **549** 012082

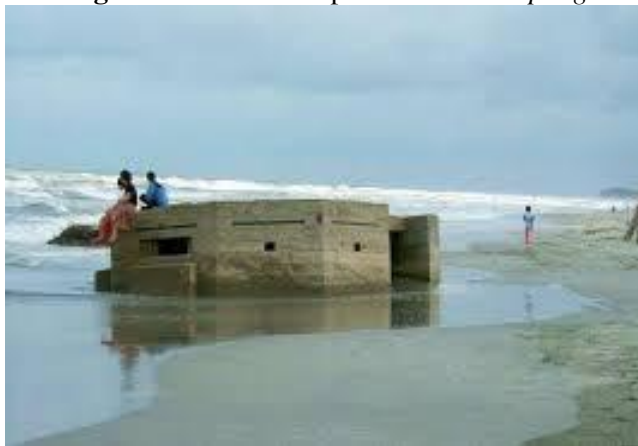
Figure 2. Pillboxes located on Bachok

Most pillboxes are rectangular in shape and contain small holes in which to place weapons for shooting. They are estimated to be three metres high and six metres wide [1]. However, some have been dissolved by erosion of the waves (Figure 2).

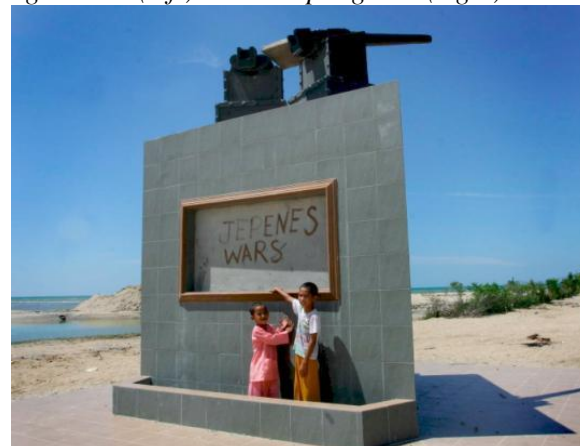
Figure 3. Monument at Sabak Beach

The pillboxes at Sabak Beach are stronger than other pillboxes. This is because they were built to defend the Pengkalan Chepa airport, which is an essential British military logistic settlement. Sabak Beach was also chosen due to its strategic location near Thailand and Vietnam [6]. However, these pillboxes have dissolved as a result of coastal erosion, leaving only the monument of war shown in Figure 3.

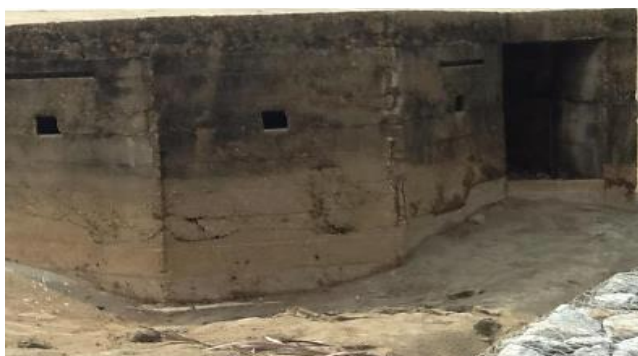
Figure 4. A sunken pillbox on the shores of the Bachok coast.

Some of the pillboxes have been displaced from their original location due to erosion by the sand dune that occurs every year, as shown in Figure 4 [8]. One pillbox located in the Kampung Lalang Luas, Machang, has been abandoned in the bushes (Figure 5) and according to Hassan Mohd Noor, is believed to be the area in which the first aeroplane landed (2019).

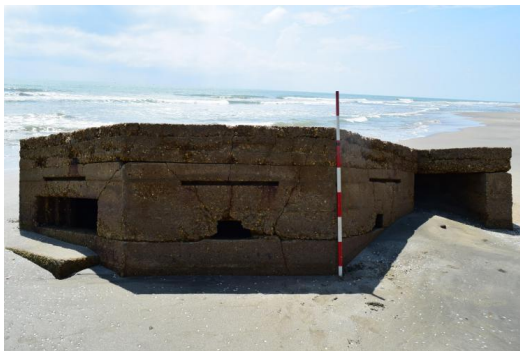
Figure 6. The pillbox at *Kampung Kubang Kawah*, Bachok

Field surveys of both pillboxes were carried out on 24.5.2017 to provide an initial overview of the location. This showed that these pillboxes are precarious for example, the pillbox located at Kampung Kubang Kawah has almost submerged into the sea (Figure 6). The site of the pillbox in Kampung Ger is located near to the local chalet. However, the beach is contaminated by debris which makes this area unattractive to tourists (Figure 7).

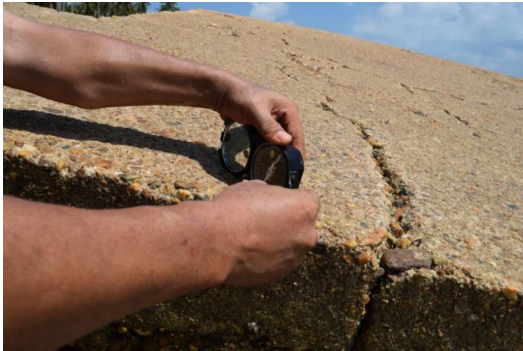
Figure 8. Geological Compass

The geological compass is an instrument used to measure the position of any elements of a geological structure. Its function is to determine the wind direction at the pillbox and the position of the erosion of the pillbox, as shown in Figure 8. In general, observation enables researchers to gain experience through practical work driven by curiosity. It can raise awareness of physical phenomena affected by human behaviour in the area. Using these methods, we determined the level of the pillbox by the changing colour of the sand. Figure 9 shows the colour changes at each water level. The change in sand colour begins with the water's edge labelled at Level 1, Level 2, Level 3, and so on. This method not only involves looking at changes in the sand, it also shows the destruction of the pillbox. This was marked to determine its type and causes, as shown in Figure 10.

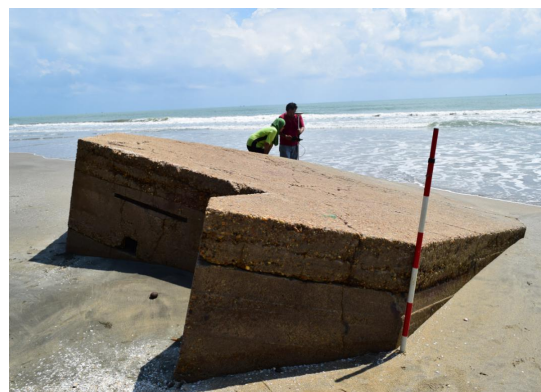
Figure 11. Determining the coordinates of the pillbox

To determine the position of the pillbox at sea level, area mapping was carried out using a pro-map gauge that provides an accurate high-quality signal to acquire the coordinates of a specific location (Figure 11). Initially, the datum point was defined as the starting point for performing area mapping. This was obtained by looking north of the pillbox and was also considered the end point of the mapping. Once the datum point was acquired, approximately four area coordinates of the pillbox area were retrieved and marked. The data was then analysed and the position of the pillbox at sea level became clear.

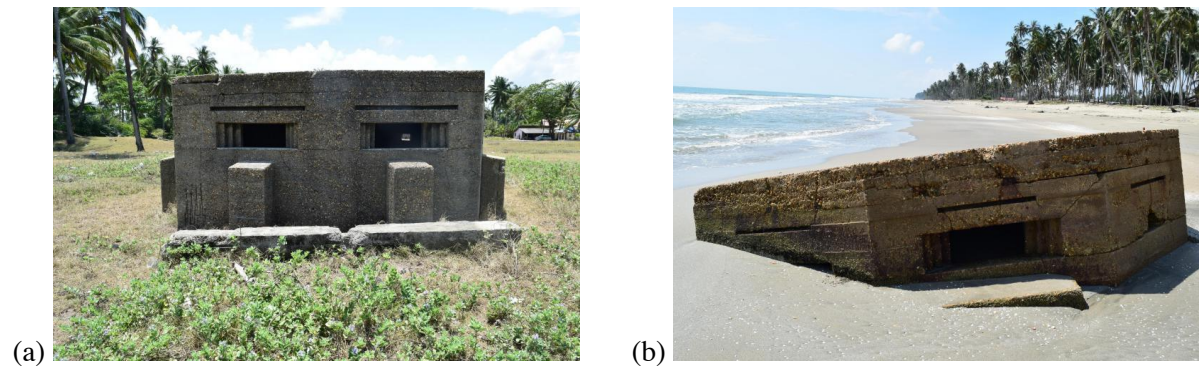
Figure 12 (a) and 12 (b). Recent state of war camps in *Kampung Ger* and *Kampung Kubang Kawah*

The construction of war pillboxes around the shores was intended to protect the state of Kelantan from invasion by the Japanese via the South China Sea on December 7, 1941. The pillboxes around the Bachok area, especially in Kampung Kubang Kawah and Kampung Ger, were constructed of similar materials [9]. They were formed in the shape of a horseshoe with a 9-foot square. The top and wall of the pillbox was made of a mixture of cement and sand reinforced with iron bars. Its estimated thickness was 9 inches. The use of cement, sand, and gravels as the main ingredient in the construction of the pillboxes was to ensure their durability for a long period during the war. Each pillbox also had its own dimensions in terms of the openings at the wall, which varied according to the type of weapons used, such as MK-4 or MK-5 guns. The varying number of soldiers assigned to the pillbox also influenced its size. According to the Malaysian military officer, each pillbox usually housed five to 10 soldiers [8]. In addition, according to Mrs Wan Mahiran, who is the daughter of Wan Seman, founder of the Irama Beach Resort at Kampung Pulau Belongan, the pillbox in Kampung Kubang Kawah is slightly smaller than the pillbox in Kampung Ger [10]. The pillbox at Kampung Ger shown in Figure 12 (a) is still in good condition with only a little damage whereas the pillbox at Kampung Kubang Kawah shown in Figure 12(b) is half-ruined due to sand erosion.

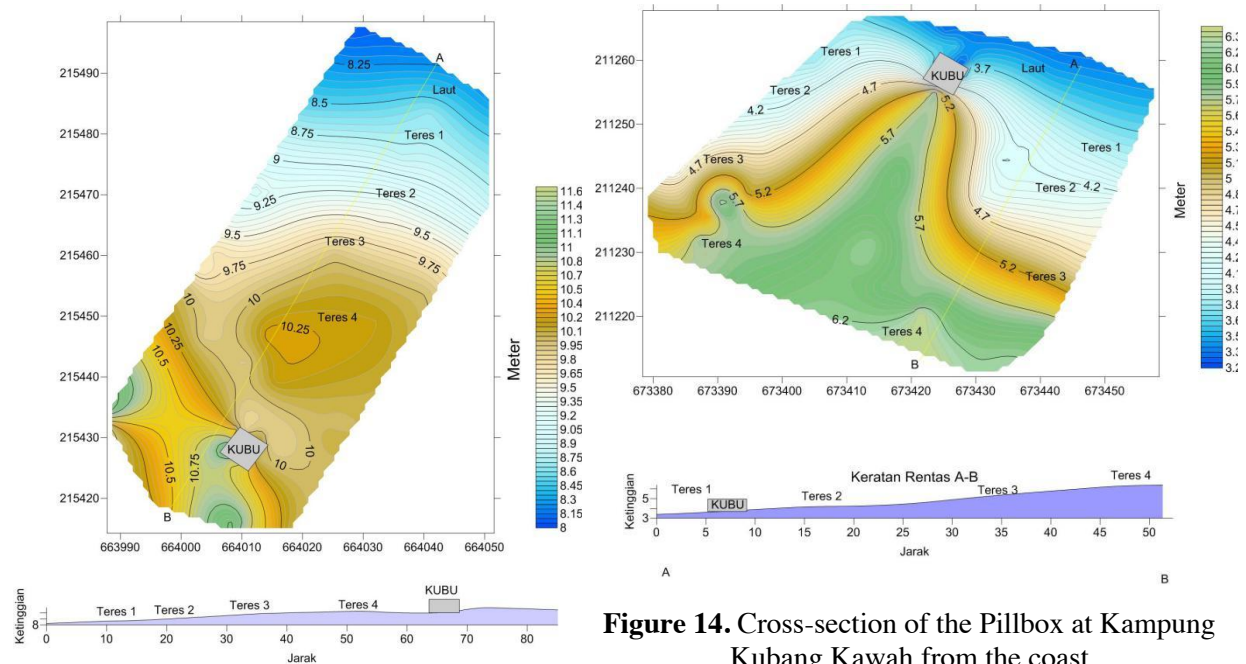
Figure 13. Cross-section of the Pillbox at *Kampung Ger* from the coast

As shown in the cross-section in Figure 13, the pillbox in *Kampung Ger* is still inland, and the distance to the coast or the tides is approximately 60-70 metres from the 4th terrace at a height of 10.7 metres from the coast. The pillbox at *Kampung Kubang Kawah* is 5-10 metres from the beach from the first and second terraces which are at a height of 3 to 5 metres (Figure 14). When the tides hit the pillboxes, causing the dunes to overflow, sedimentation occurs. This deposition process has caused the pillbox at *Kampung Kubang Kawah* to sink deeper into the sea and has made its historic preservation difficult.

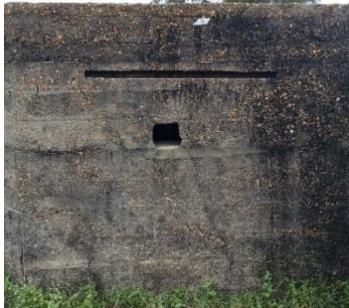
<p>The serious growth of [D1] moss in part B caused the surface of the wall to turn black.</p>	<p>Section G</p>

As presented in Table 1, the analysis showed that Part B is exhibiting a severe growth of [D1] moss, which has caused the walls to turn black. [D1] Moss is a type of parasitic organism capable of eroding the barriers of a pillbox when humic acid forms during its growth process. This growth is caused by several key factors, such as light, temperature, and humidity. The location of the pillboxes on the shoreline caused the moss to grow rapidly as it was exposed to light, heat, and moisture, thus affecting the structure of the pillboxes. The condition of the unarmed pillboxes also caused the growth

of the moss to become more serious, resulting in a black strike that caused the structure of the pillboxes to become unstable.

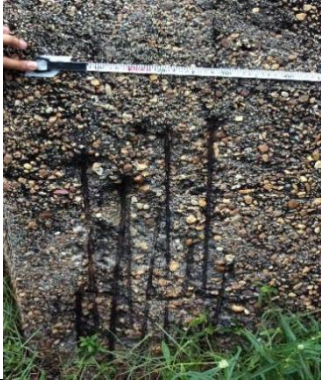
<p>[D3] Iron deposition is occurring on the lower part of the G wall due to environmental change.</p>
<p>Section E</p>

[D3] iron deposition is also taking place on the lower wall of G due to the presence of water and air. The erosion of the pillboxes on the shores has destroyed the concrete walls and led to the formation of steel reinforcements. When exposed to air and saltwater, these further accelerate the healing process and cause the pillbox to become unstable, leading to further damage such as fractures. A severe crack (D2) on the concrete pillar of the interior of the pillbox caused by the pole almost led to its collapse. This is because an influx of seawater and strong winds has contributed to the destruction of the structure of the pole.

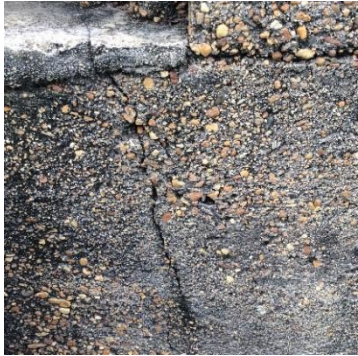
<p>There is a [D2] crack on the E. wall.</p>	<p>Section G</p>

There were both fine and medium [D2] cracks on the wall surfaces of sections E and G. Section E had a 50cm soft fracture while the upper part of G had a 73cm rough fracture. This is due to the acceleration and expansion of battlefield structures exposed to unpredictable weather. Erosion is also affecting the pillbox structures due to their position on the coast.

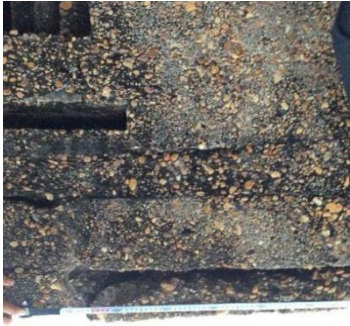
<p>An extremely serious crack at the top of the wall has occurred in Section G [D2].</p>
<p>The interior of the pillbox</p>

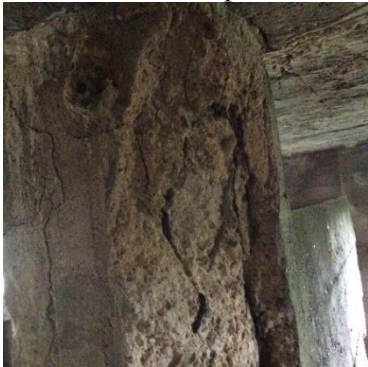
<p>The occurrence of [D2] cracks in the inner columns of the pillboxes is serious.</p>

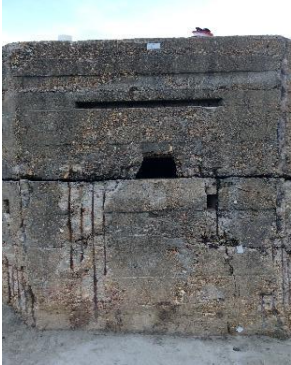
[D4] serious deposition occurs due to the coastal location of the <i>pillboxes</i> .	Section E, F, G & H

As shown in Table 2, section B has experienced [D2] 30 cm thickening on the steel reinforcement due to corrosion that has destroyed the concrete coating of the pillbox wall. Consequently, there was severe deposition on the wall of Section C. This deposition occurred due to the location of the pillbox off the coast. There was an obvious 63cm crack in the E side of the wall. This fracture is caused by environmental factors such as deposition and erosion. This has resulted in the structure of the pillbox becoming unstable and led to the destruction of the wall surface. If left unattended, violent fractures may occur that can destroy the pillbox structure at any time.

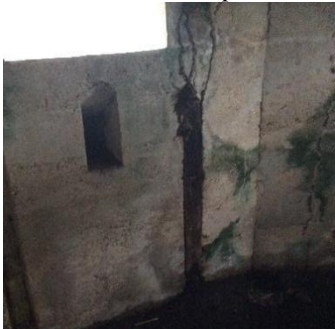
Evidence of [D6] termite attacks and moss growth [D1] on the inner wall structure of the <i>pillboxes</i> .

The interior of the pillboxes at Kampung Kubang Kawah has also experienced [D1] moss growth and [D6] termite attacks. As described in Table 4.2, the growth of moss is due to temperature, light, and humidity factors. The internal conditions of the enclosed pillbox and near the shores have led to air dampness. This moisture has accelerated the growth of moss and caused mechanical damage. Termite attacks have also weakened the structure of the pillboxes. Subterranean termites usually build their nests in damp and wet places because they require a substantial amount of water to survive. As shown in Table 2, termites have built their nests on the inner walls of the pillbox and caused severe damage, such as holes in the walls. This is also contributing to the destruction of the pillbox.
