A REVIEW ON THE IMPACTS OF PLANTS TOWARDS HERITAGE BUILDINGS

Ayub Awang ^{a,*}, Mohammad Rusdi Mohd Nasir ^b, Wan Saiful Nizam Wan Mohamad ^c

^{a,b,c} Faculty of Architecture and Ekistics, University Malaysia Kelantan, MALAYSIA

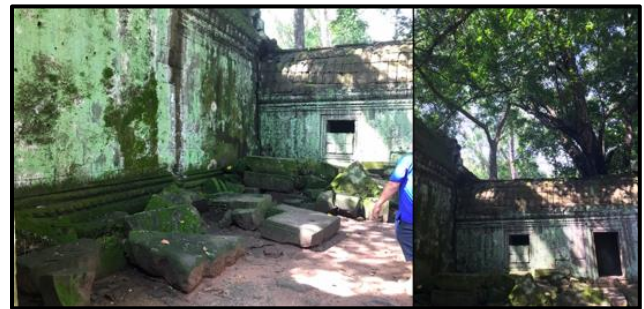
Figure 1. Dampness level on the walls of Ta Prohm temple, Cambodia causing moss and green stains due to plant or tree canopy blocking the sunlight from reaching the lower part.

The presence of plants surrounding the building area could cause dampness and high humidity on the wall surface and internal parts that then activates moss and green stain production (Ahmad, 2018; Kayan, 2006). Such cases can be observed on Angkor temples in Cambodia which the plant canopies are appear to prevent the sunlight to reach the building surface and created moss, shady and damp area (Giulia Caneva et al., 2015). This situation also occurs in the temple of Ta Prohm where high humidity due to plant canopies covering the temple floor promote fungi, algae and moss growth. Besides, moss and fungi that grow there could emit spores into the air that can lead to harmful threat and endanger the occupants' health (Bakri & Mydin, 2014).

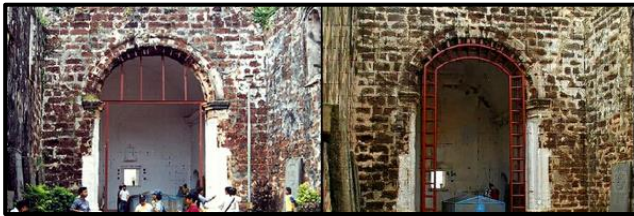
Figure 2. Picture of before and after the presence of ornamental plants at the both sides of of St. Paul & Santiago Gate/A' Famosa's entrance, Jalan Kota Melaka, the word 'Melaka already diminished from the building. (Source: website ntqt.com.my)

Based on the current landscape maintenance in the heritage building area, plants watering and fertilizing should be reduced to prevent the increase in humidity and salt absorption levels (Young, 2008). This also causes stunt growth in ornamental plants that will produce such poor

landscape view visually. Besides, lower level of nutrients and water on the other hand will force the roots to move further towards the buildings to get nutrient and water source. Furthermore, the bricks manufacturing process requires some important elements such as Fe, Mn, Zn, Cu, SO₂ and NO₂ where these elements are macro nutrients for plants' growth (Sikder, Begum, Parveen, & Hossain, 2016). Therefore, bricks could also act as a good plantation medium especially for crawling, climbing, and hitchhiking-types of plant. Damp soil can activate mineral salt to be absorbed through the building structure. Fertilization practice also provide source of salt to the plant medium (Young, 2008). Both practices not just making the plant to grow better but also providing salt to the heritage buildings which already in poor condition.

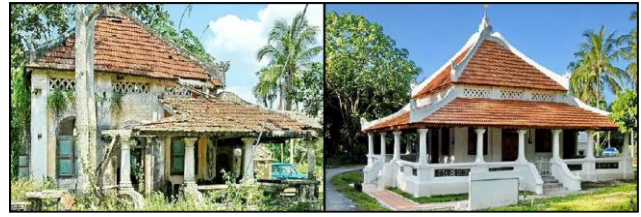
Figure 3. Picture shows before and after the component damage of the building due to plant invasion in Kg. Gadong mosque, Rembau Negeri Sembilan. (Source: website ntqt.com.my)

Buildings and pavement area facilitate the growth of the plants either from local or exotic species with the support of pollination activities through wind, animals, and human as their spreading agents (Jim, 2013). Besides, roots of crawling type of plant such as ivy can cause some cracks on the walls of the heritage buildings as well as contributing to water leaking through the structures (Ahmad, 2004; Hollis, 2005; Kayan, 2006). This condition creates dampness not only on the external part but also the internal part of the buildings.

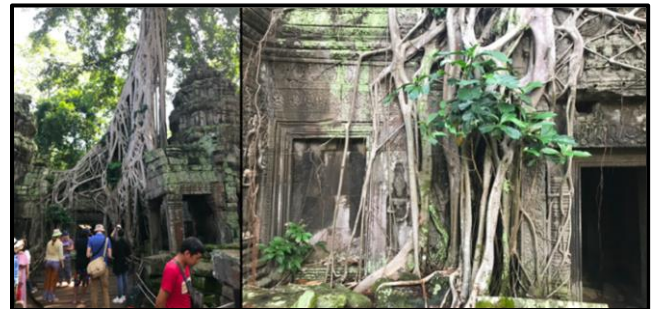
Figure 4. Domination of the plant's roots damaging the structures of Ta Prohm's temple, Cambodia.

The pollination process of such plants is easy because some of their fruits are food source to the birds. Just like in Ta Prohm's temple, Cambodia. The seeds that fall onto the temple surface eventually grow due to the nutrient source that available there. When the plants continue to grow bigger, their roots then keep expanding and causing the bricks to move apart from each other thus damaging the temple's walls (Lakshmipriya, 2008). The presence of this type of plants should be considered as serious threat towards heritage buildings because their capability to cause intense damages to the structures.

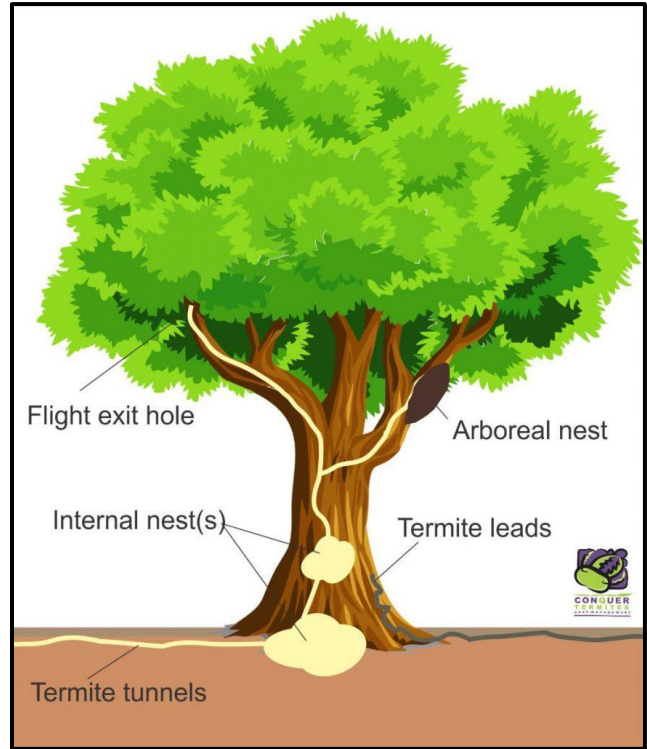
Figure 5. The condition of the tree after was attacked by the termite. Source: website conquertermites.com.au)

Plants are one of the habitats that support the termite and carpenter ants. Termites are identified to live in the dead wood or dead components of tree such as logs and stumps where it require moisture to build nest (Noirot & Darlington, 2000). This could cause the trees to break down and fall

when exposed to strong wind that also endangers the nearby surrounding area (Conquer Termites, 2020). This directly will harm and threaten the occupants and nearby buildings. Termites exist and inhabit tropical and subtropical regions either in damp or dry conditions including countries in Africa, South America, and South East Asia (Verma, Verma, & Sharma, 2018). Termites are one of the main enemies for buildings constructed by using woods as their materials. Termites are so hard to detect and trace due to their nature in invading and inhabiting the internal components of the dead wood and could survive within the cracks of the concrete buildings. The termites of the subterranean type (*Coptotermes curvignathus*) bring damage to the timber structure as well as the concrete foundation of the building (M. Tan, 2009). For the buildings constructed with bricks and concrete materials, the wood components are usually located at the roof area which is difficult to reach due to its high position from the ground. Because of that, any inspection and maintenance on the structural damages is hard to carry out. Fragile plants are not a suitable material to be used because it will attract more termites to build their colony. Termites can be found in the building area surrounded by plants and trees because this insect usually builds their nest in the form of arboreal nest, tree trunk nest, tree stump nest, mound nest and embedded nest in landscape timber (Conquer Termites, 2020). The probability for the termite colonies to move from one place to another is high if there are trees and plants located near the buildings.

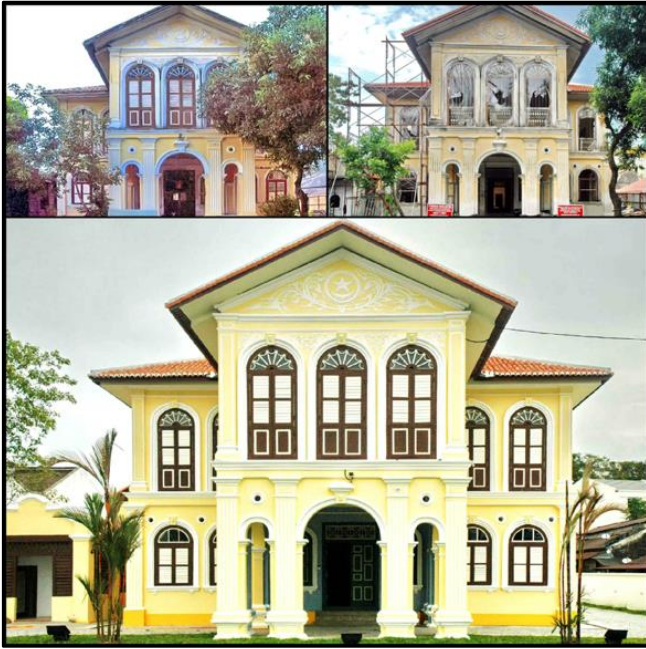
Figure 6. Photo of Rumah Teh Bunga, Pulau Pinang before the presence of surrounding plants and the house after the conservation work taken place showing only turf grass and red palms (*Cyrtostachys renda*) as the landscape main elements. (Source: website ntqt.com.my)

Due to the serious damages done by the plants onto the heritage building, there are two measures taken by the conservators to help dealing with such problems; - cut off the nearby trees and minimize the number of plants after completing the conservation project. The cutting off process usually will be carried out after the building inventory works before the conservation. Besides reducing the maintenance works on the heritage building, some landscape plants are not being planted anymore or reducing its number after completing the conservation work (Ahmad, 2018). Based on projects handled by NTQT, only turf grass and red palm (*Cyrtostachys renda*) is planted on the frontyard area of Rumah Teh Bunga in Pulau Pinang. While, the mango tree (*Mangifera indica*) at the side of Ayer Barok mosque had been removed after conservation work. This situation could certainly save the buildings but it effects the spirit and nostalgia values of the place compared to the atmosphere before the conservation work. This was driven by lack of scientific understanding and nature of plants is often a problem in preserving old buildings (Jim, 2010). In addition, the lack of knowledge in building conservation has led to poor and inadequate solution methods (Ahmad, 1994; S. Y. Tan et al., 2016).

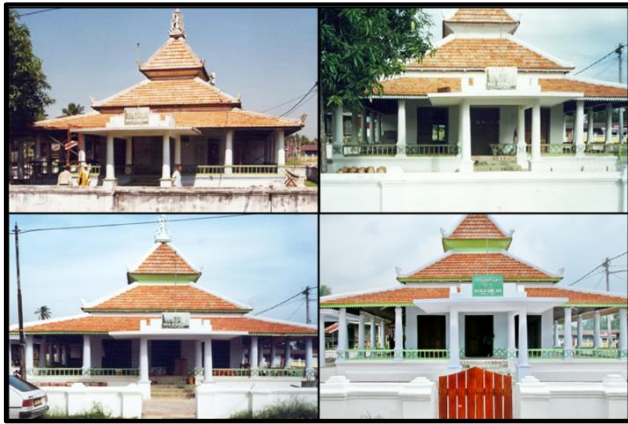
Figure 7. Conservation work in Ayer Barok mosque, Malacca showing the presence of mango tree (*Mangifera indica*) at the side of the mosque. (Source: website ntqt.com.my)
