ANALYSIS OF HOUSING RECONSTRUCTION FROM RESIDENTS' PERSPECTIVES AFTER THE 2014-FLOOD IN KUALA KRAI, KELANTAN

Abstract

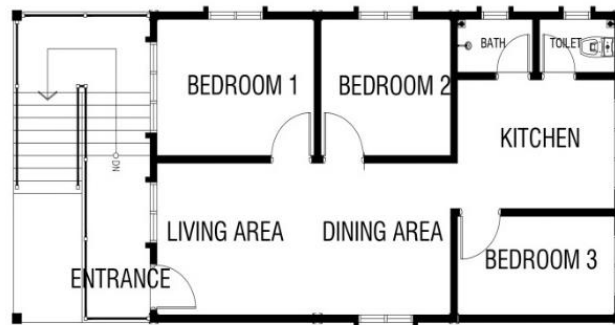
Figure 1 : The floor plan of RKB1
(Source: Hanafi et al., 2021)

units of RKB built across Kampung Manik Urai, consisting of two types of design, namely, Type 1 (RKB1) and Type 2 (RKB2). The beneficiaries were given the option to choose the house type according to their preferences. RKB1 was built on stilts 2.4 meters above the ground. The floor area is 62 m² which consists of spaces including a living and dining area, three bedrooms, one kitchen, one bathroom, and one toilet, which was illustrated in the floor plan in Figure 1. Figure 2 shows the overall 3D image of RKB1. The other design, RKB2, which was built on the ground, had a more extensive floor area (76 m²). The house consists of a living and dining area, three bedrooms, one kitchen, and two toilets, as depicted in the floor plan in Figure 3, while the overall 3D image of RKB2 is shown in Figure 4.

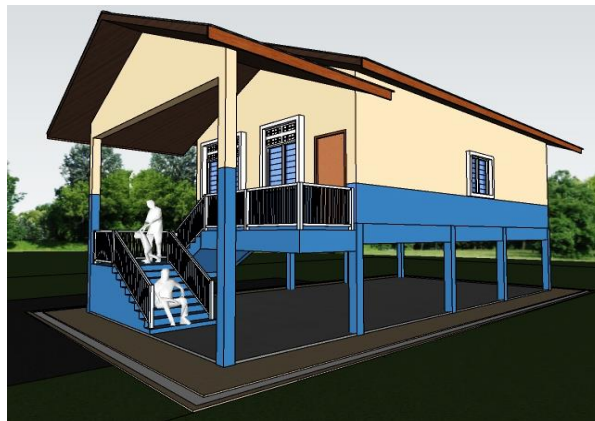
Figure 2 : The 3D image of RKB1
(Source: Author)

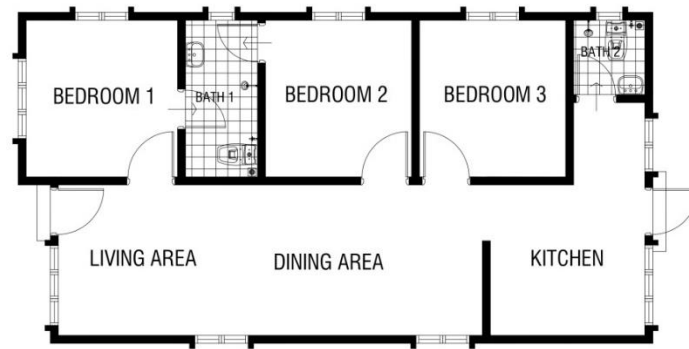
Figure 3: The floor plan of RKB2
(Source: Hanafi et al., 2021)

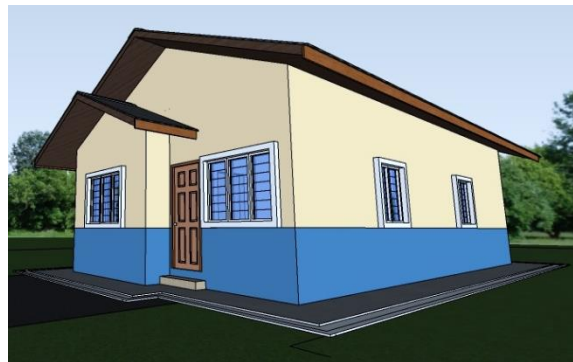
Figure 4 The 3D image of RKB2
(Source: Author)

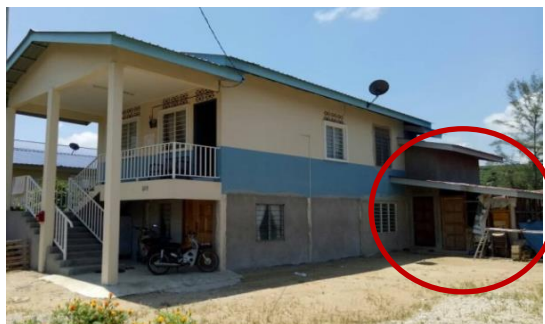
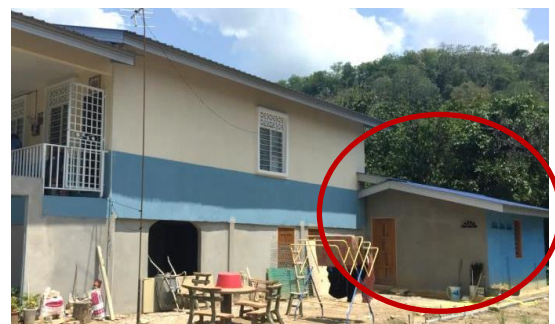
Figure 5

Residents in RKB1 notified that they encountered inconveniences with the provision of a single staircase and access door in the house layout. They underlined the inefficient circulation and difficulties in their daily activities, especially activities or chores related to the kitchen and back of the house. Furthermore, the single entrance would impose risk and unsafe conditions, especially during an emergency. Consequently, this research identified extensions constructed at the back of RKB1, where residents had built an internal staircase with a secondary door at the rear part of the house. In traditional Malay houses, usually, women would enter the house from the back of the house, where the kitchen and women-related spaces would be. This tradition influenced the spatial organization of the houses and thus would determine the overall house layout. The practice also resulted in the extension of some of the RKB1, as shown in Figure 3 and Figure 4 below.
